**CEDAR LAKE DAM**

**BOONE COUNTY, MISSOURI**

**PHASE 1 INSPECTION REPORT**  
**NATIONAL DAM SAFETY PROGRAM**

**SUBJECT: Cedar Lake Dam, Mo. ID No. 11058**  
**Phase I Inspection Report**

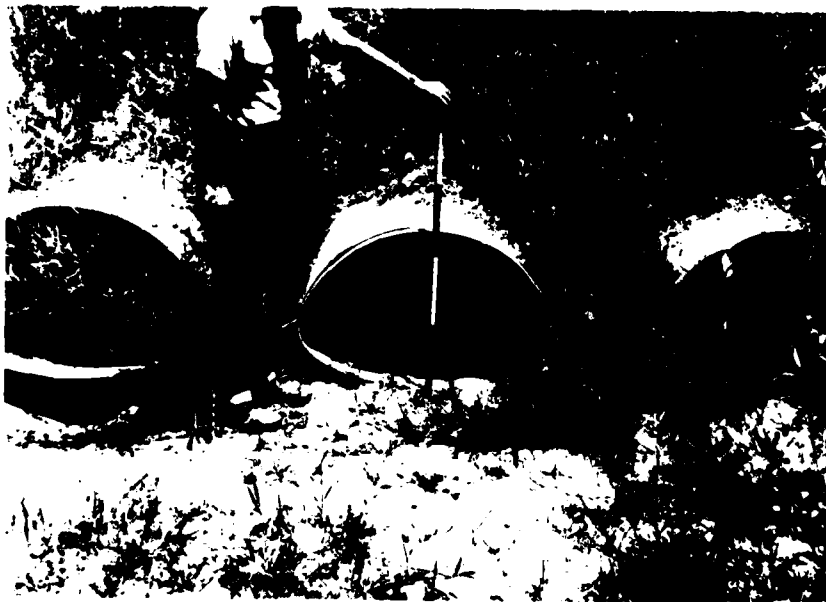
PHOTO 8: OUTLET END OF SPILLWAY PIPES
